**From:** Karen Walter <KWalter@muckleshoot.nsn.us>  
**Sent:** Monday, May 15, 2017 3:09 PM  
**To:** Johnson, Joshua R (DCI); PRC  
**Subject:** 3018093, Unit Lot Subdivision  
**Attachments:** Mapes Creek report\_WATrout 2002.pdf; Stream Habitat Report Puget Creek 022114 Final.pdf

# Assessment of Mapes Creek Habitat, Fish Passage, and Fish Species Composition and Distribution

**STREAM HABITAT REPORT**

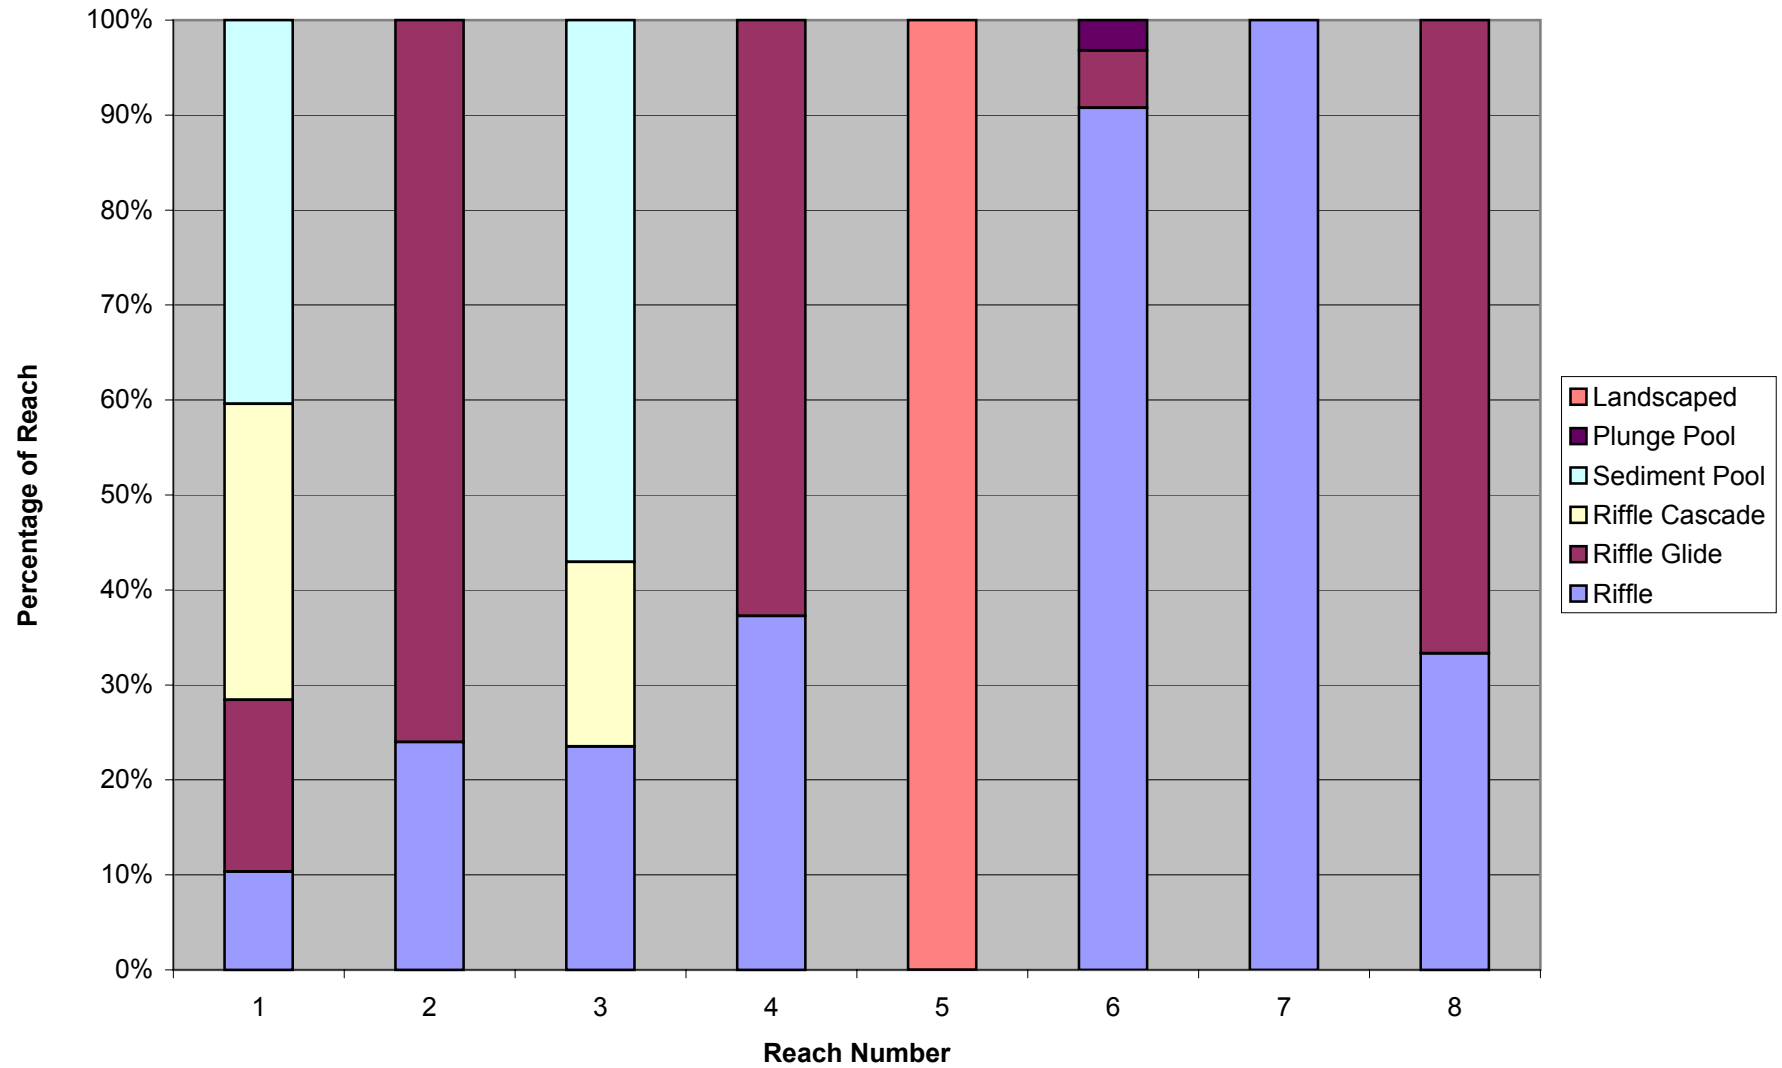
**Figure 1. Habitat Percentages by Reach**

Within the 8 reaches, 33 individual habitat units made up of five different habitat types were documented (Table 1, Figure 1). The dominant habitat types observed in the free flowing portions of Mapes Creek are riffle type habitats, which include riffles, riffle glides, and riffle cascades. Riffle type habitats comprise 78% of the total habitat types within the Mapes Creek study reaches. Riffle habitats in Mapes Creek tend to be straight, with little difference between wetted width and ordinary high water width. The other dominant habitat in the system is sediment pool habitat. This description was given to relatively broad, shallow portions of the creek that flow over a deep layer of mixed silt and organic sediments, often with emergent vegetation (Photos 14). The observed sediment pools are the result of three forming factors: flow constraint, gradient, and sediment supply. Flow constraints cause a loss of hydraulic energy and result in the deposition of the stream's suspended load. In Reach 3 these constraints are concrete weirs that span the width of the stream. In Reach 1, two factors have caused the formation of the largest sediment pool in the system: the low gradient where the sides of the ravine pinch together, and the rock weir just upstream of the Sturtevant/Rainier culvert. The other forming factor for these pools is an abundance of fine sediments from the watershed. These sediments were likely mobilized during the construction of both the surrounding neighborhoods and Kubota Gardens, and may be exacerbated by the addition of sediment-laden stormwater runoff. All of Reach 5, the portion of the stream that is incorporated into the Kubota Garden's channels, ponds, and waterfalls, was classified as landscaped habitat. The 8 ponds have an average water depth of 2 ft, vary in size from 45 x 30 ft to 90 x 50 ft in

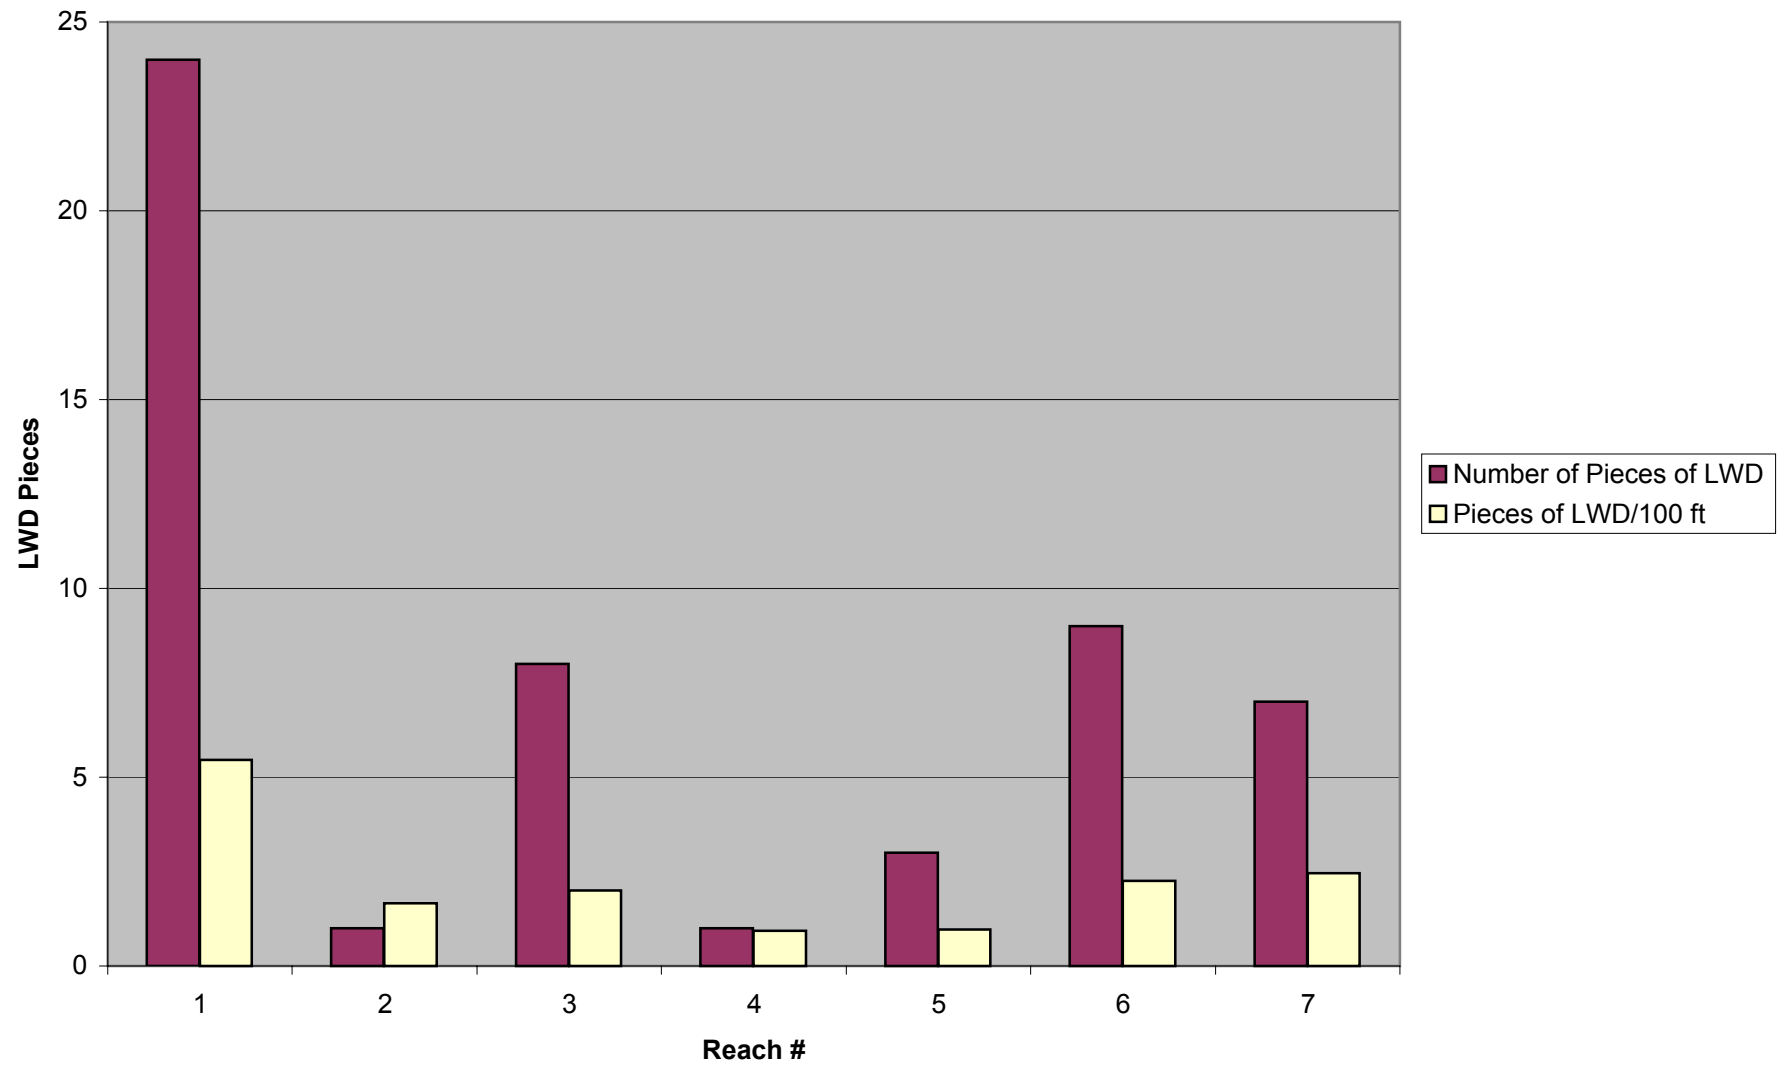
**Figure 4. LWD Characteristics**

The amount of large woody debris varies widely between reaches (Figure 4). Reach 1 has the most LWD, and the highest concentration of any reach, with the bulk of the wood being trapped in the large sediment pool that makes up 40% of the reach's length (see Table 4 for LWD characteristics by reach). Reach 2 only has 1 piece of LWD, a conifer that is substantially larger than most other pieces observed in the system. Reach 3 was similar to Reach 1 in that most of the woody debris in this reach was trapped in sediment pools. Reach 4 had a lack of woody debris as would be expected due to the artificial nature of the upstream pond system and lack of a riparian area resulting in little recruitment opportunity for the reach. No pieces of LWD were observed in Reach 5, likely because park-landscaping staff removes any that fall in. Reach 6 is more lacking in LWD than would be expected for a naturally forested area. The two upper reaches of Mapes Creek show a slight increase in woody debris density over Reach 6, but LWD is still less abundant than would be expected in a forested headwater.

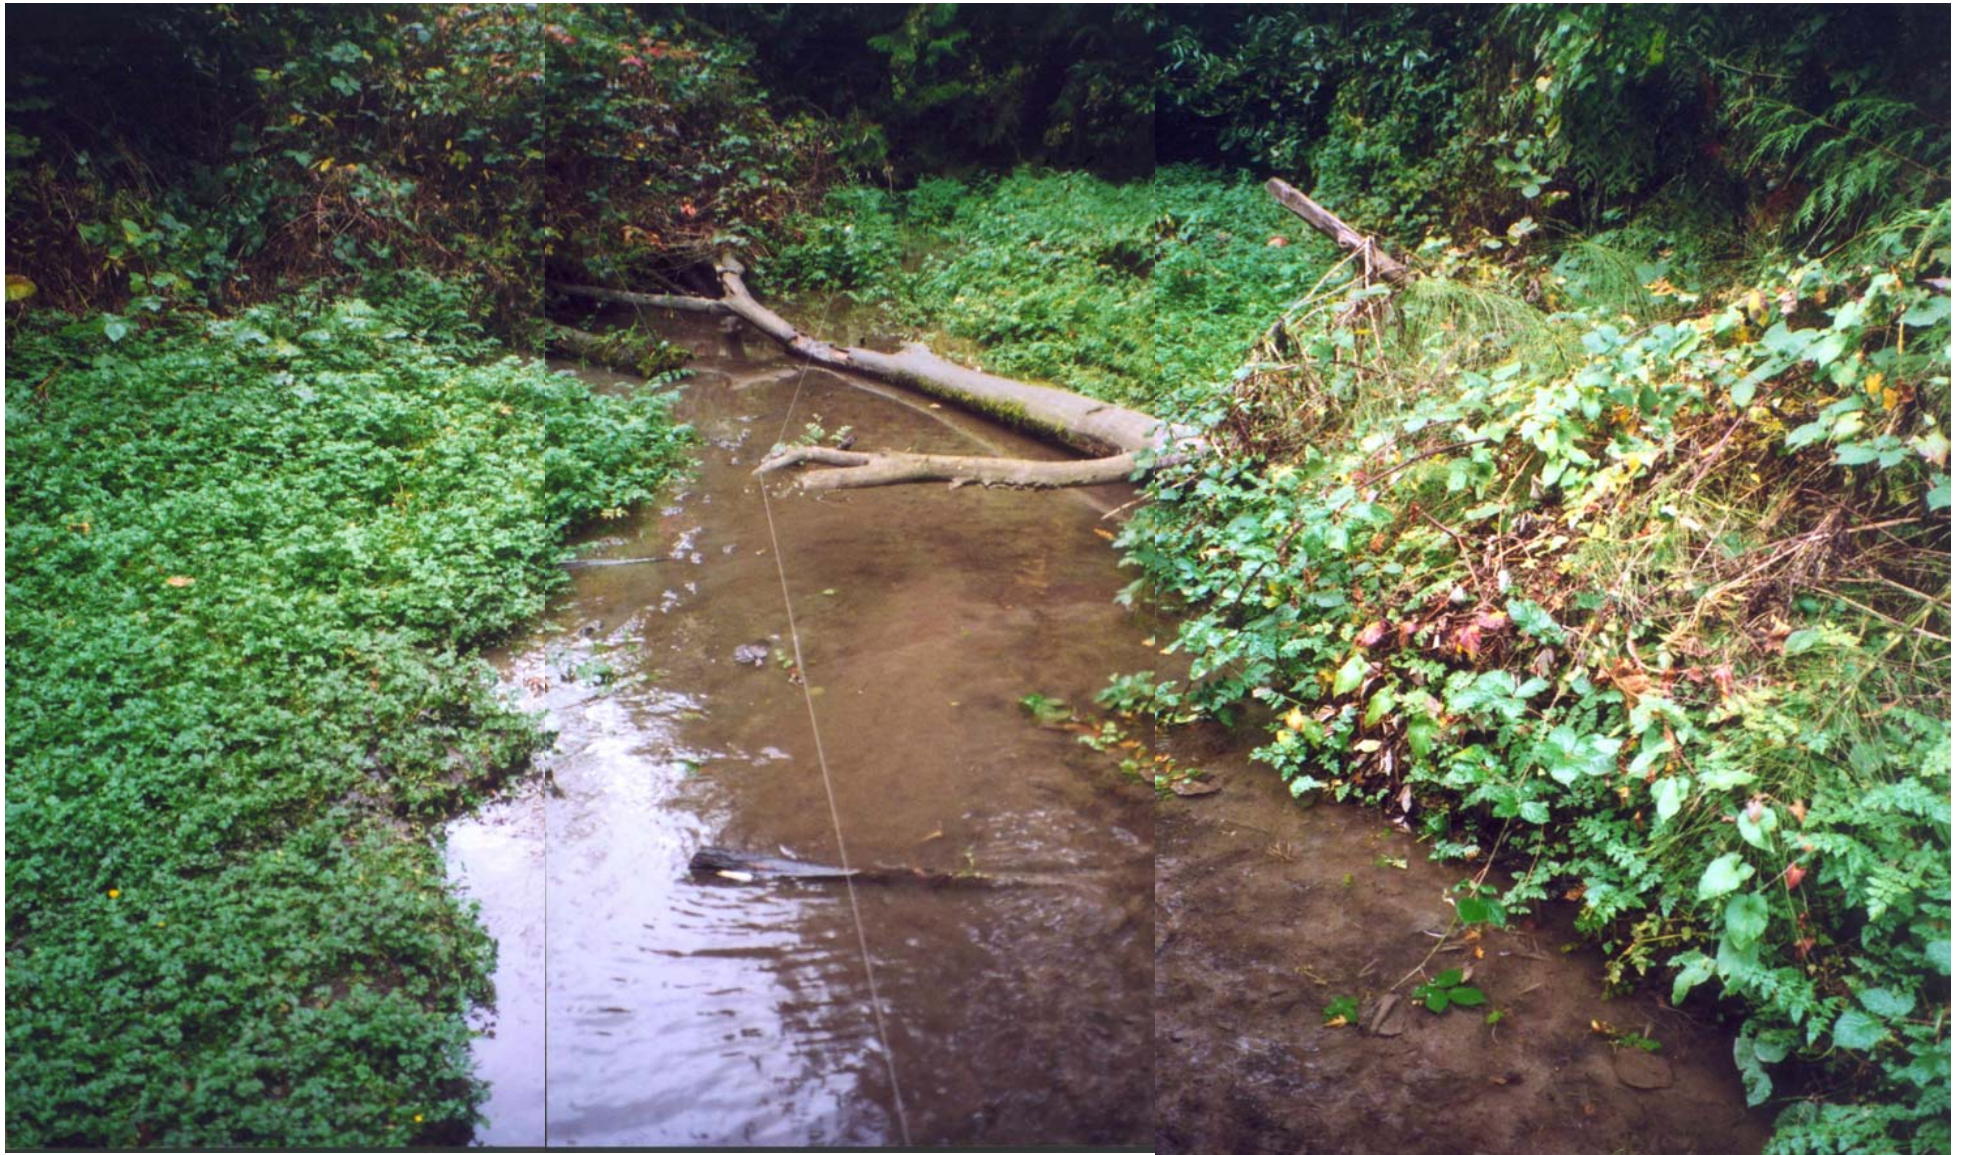
Photo 9. Downstream view of sediment pool created by concrete weir # 3, Reach 3.

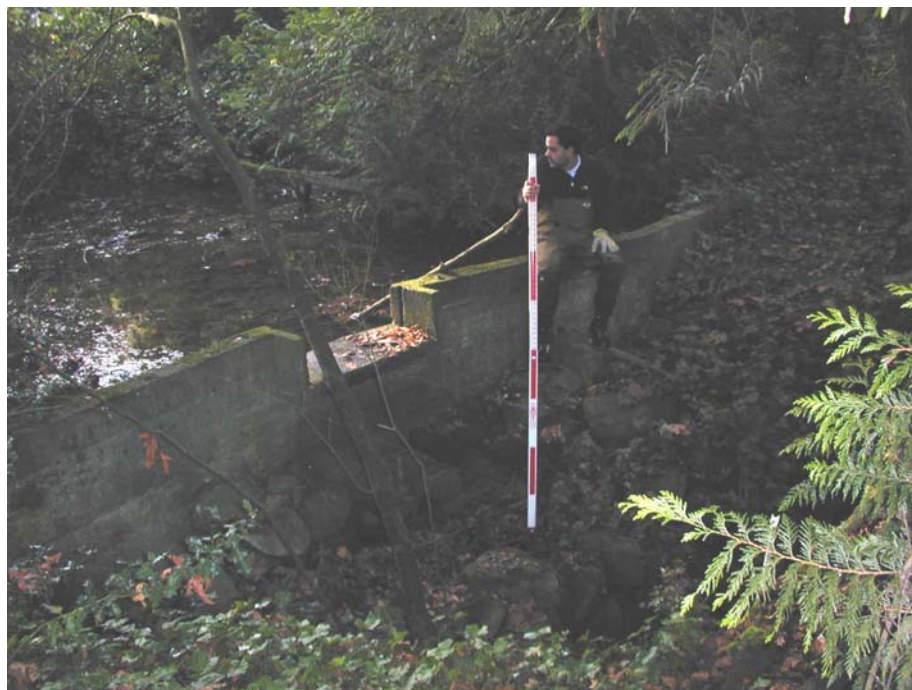
Photo 10. Concrete weir #2, Reach 3.

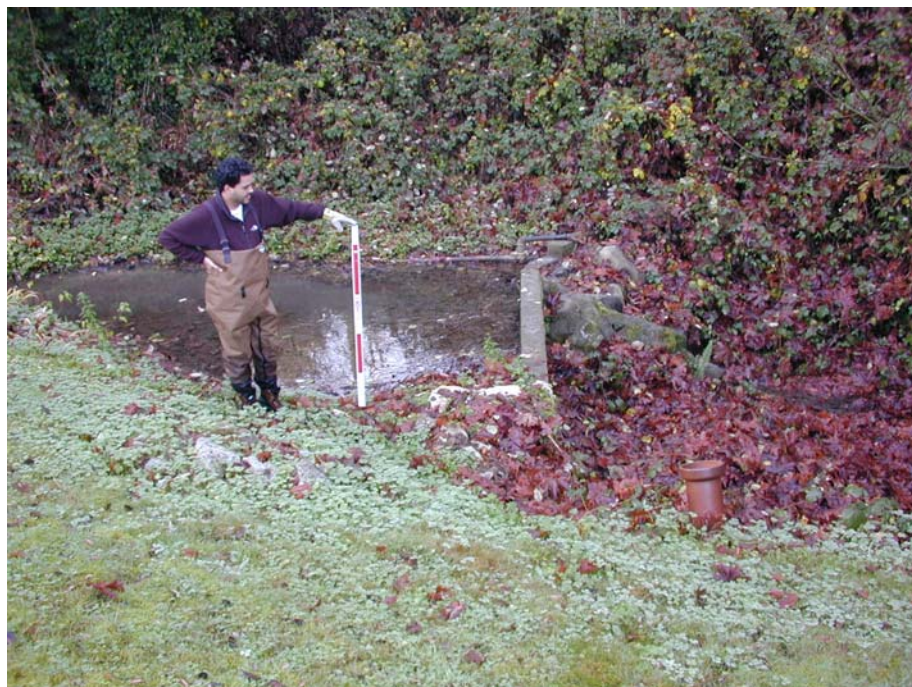
Photo 11. Concrete weir # 1, Reach 3.

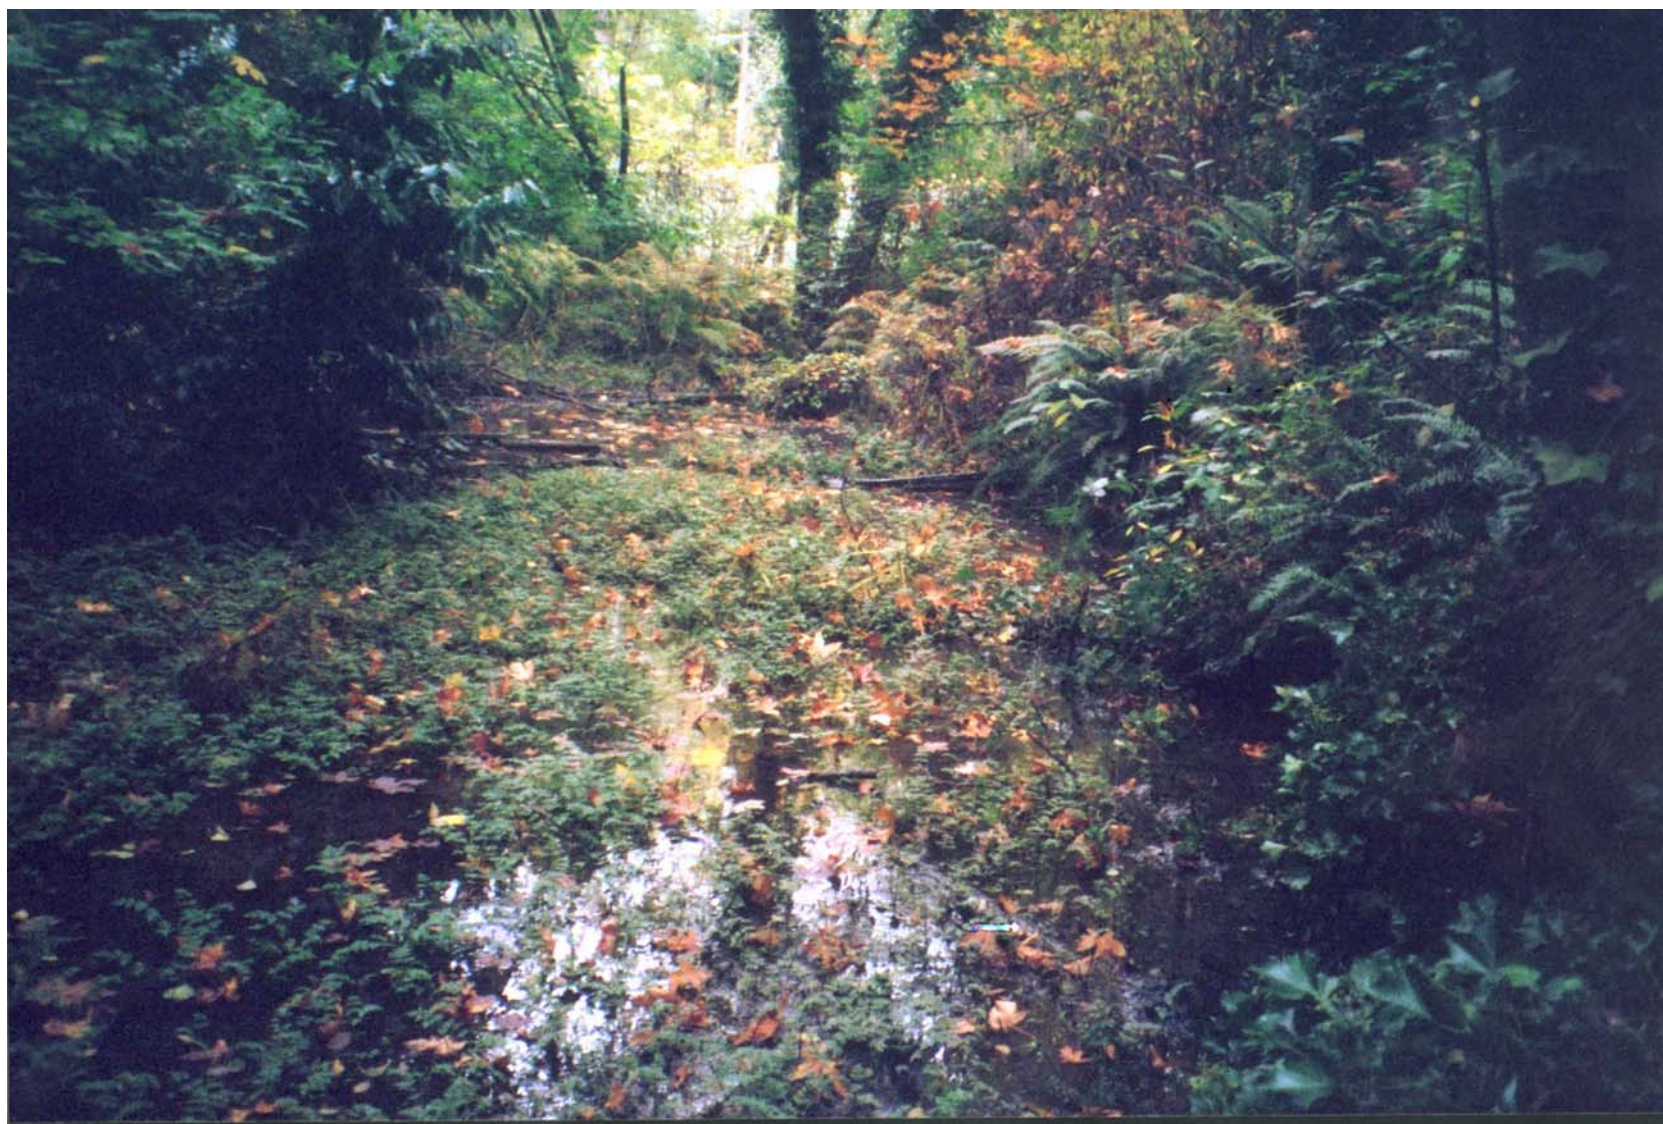
Photo 14. Downstream view of large sediment pool in Reach 1, wetted width spans entire foreground.

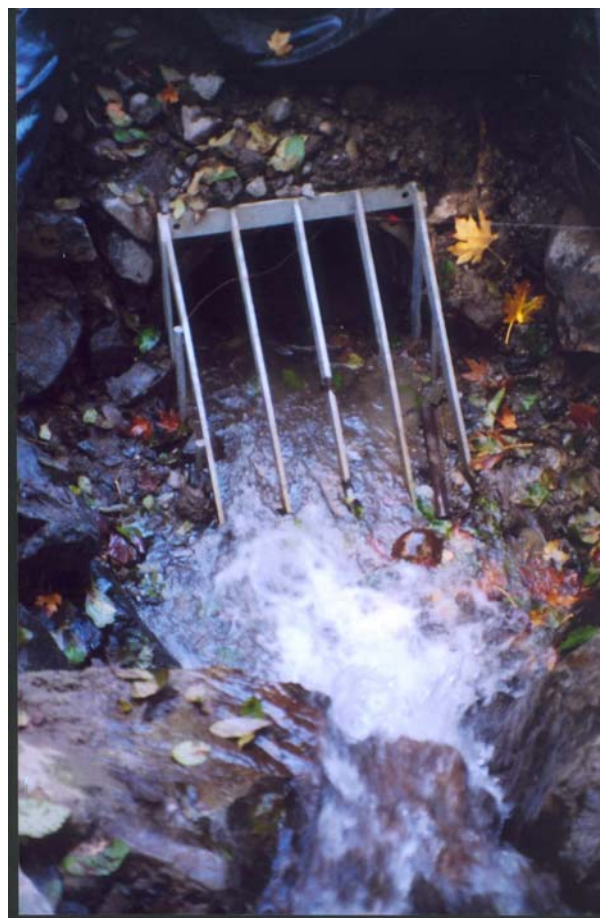
Photo 16. Inlet to Sturtevant/Rainier culvert with trash rack.

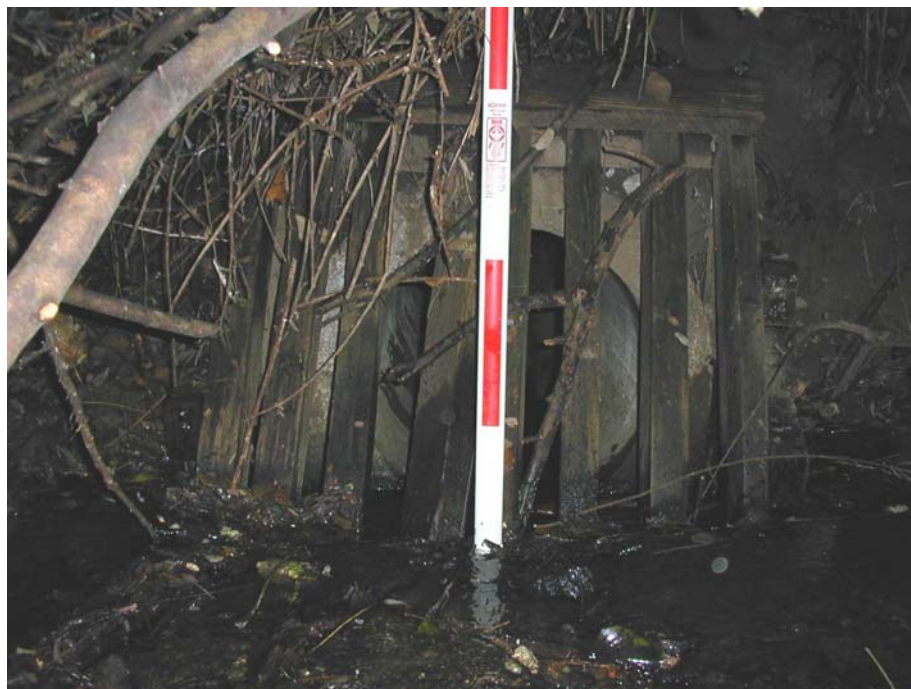
The next culvert upstream is the Renton Avenue culvert, which is approximately 233 ft long (Photo 20). The outlet of this culvert was not surveyed because the landowner denied permission to access the property. On the upstream end it was noted that the culvert consisted of a 2.5 ft diameter pre-cast concrete pipe with no substrate throughout. It is believed that this culvert would be a partial velocity barrier due to its apparent gradient and a lack of substrate.

Photo 20. Inlet to Renton Avenue culvert

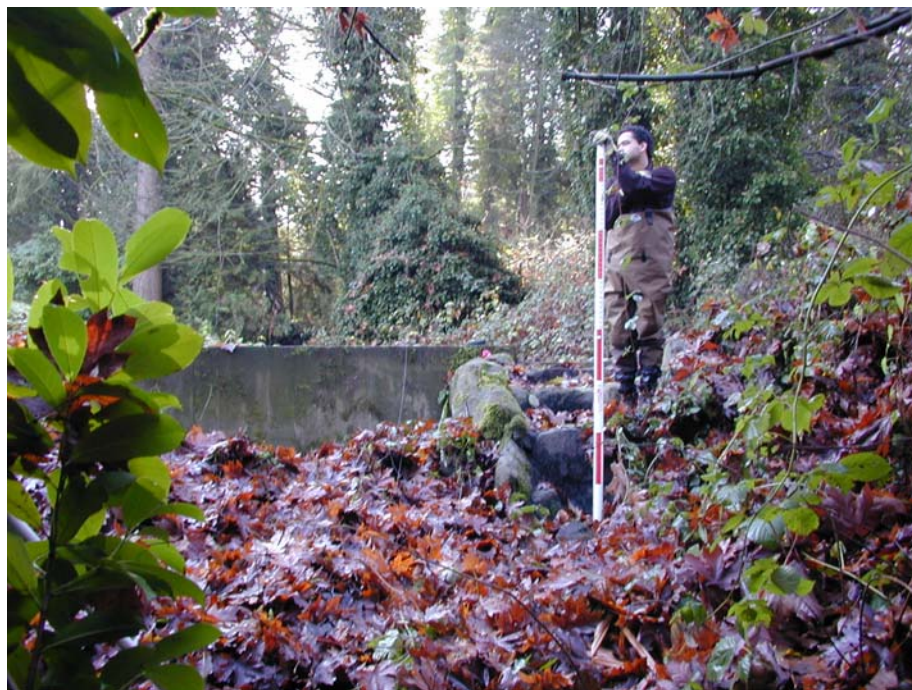
Photo 21. Upstream view of concrete weir #1

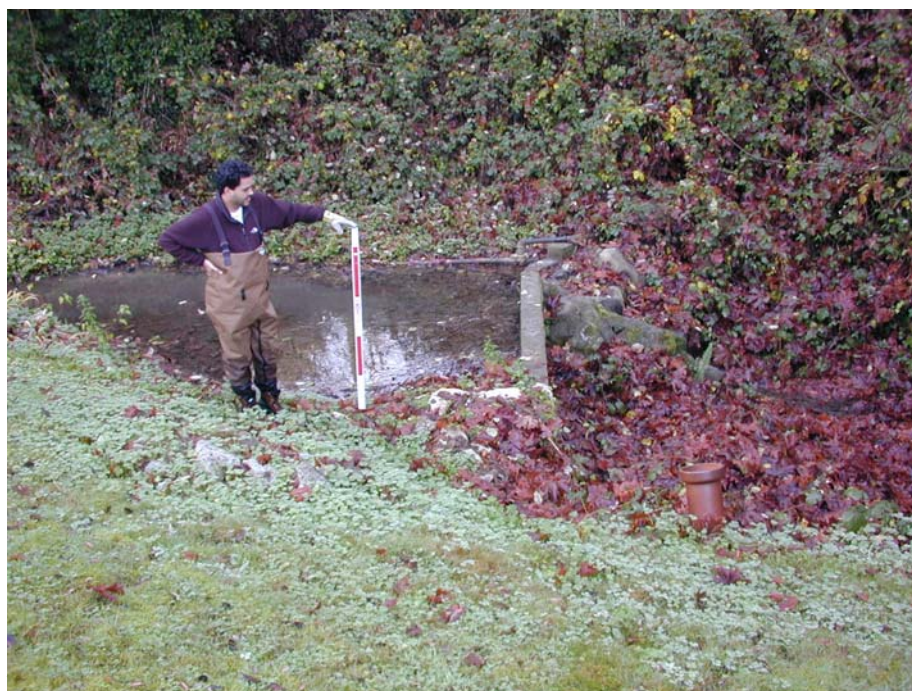
The first in a series of four concrete weirs within Reach 3, concrete weir 1 is 65 ft upstream from the Renton Avenue culvert (Photos 22 and 23). This weir is 3.7 ft high, 0.65 ft thick and 32 ft long. The intended outflow is a notched rock and concrete ladder that is no longer functioning. The creek now runs down the right bank side of the weir through a failed patch of sandbags and poured concrete. There is no plunge pool at the outlet of the weir and in its current state; the weir is a full barrier to adult and juvenile salmonid migration.

Photo 22. Side view of concrete weir #1

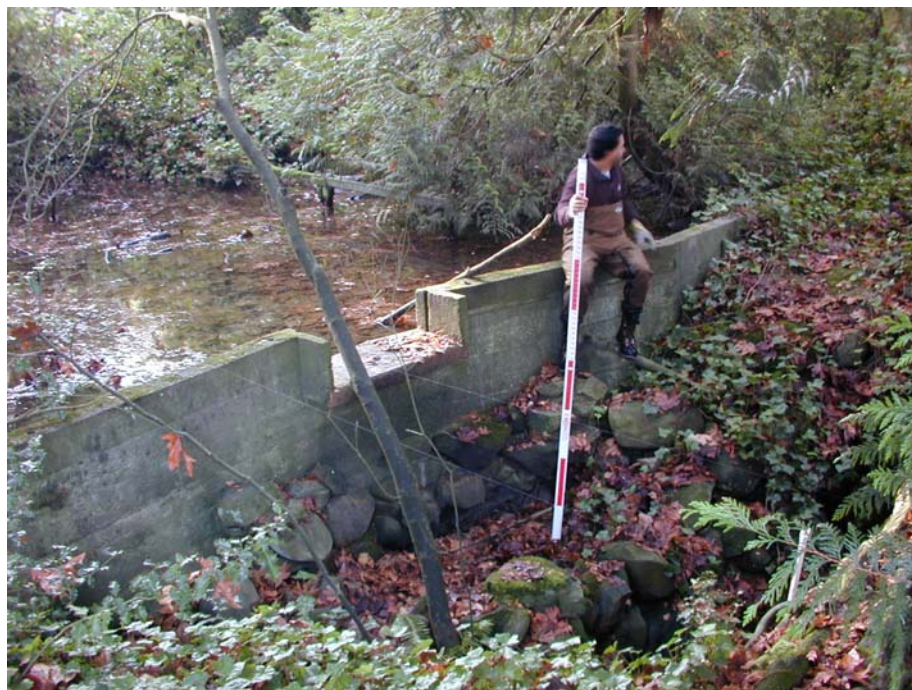
Photo 23. Concrete weir #2

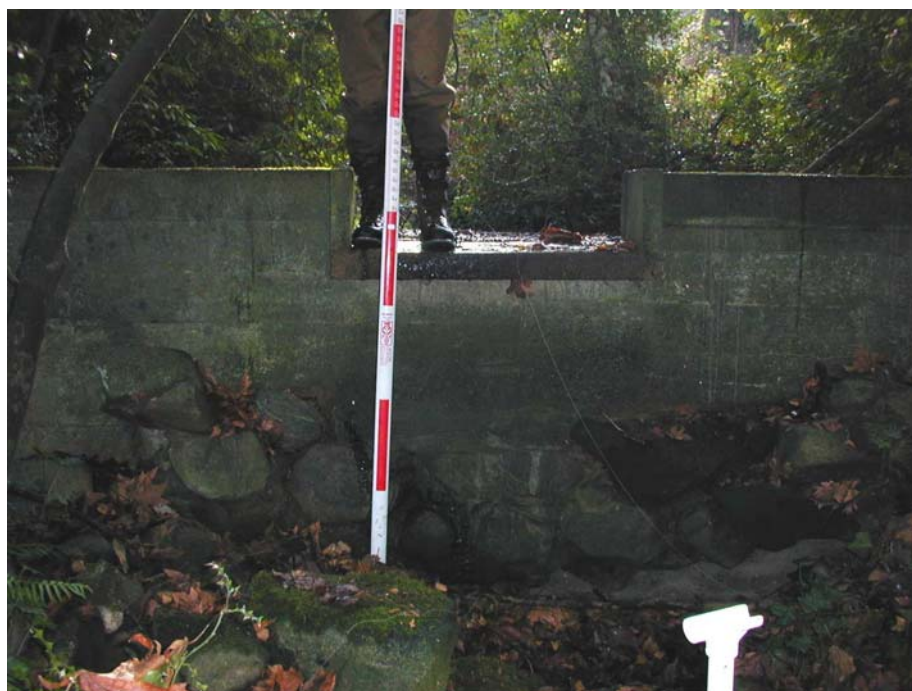
Photo 24. Uppermost drop on concrete weir #2

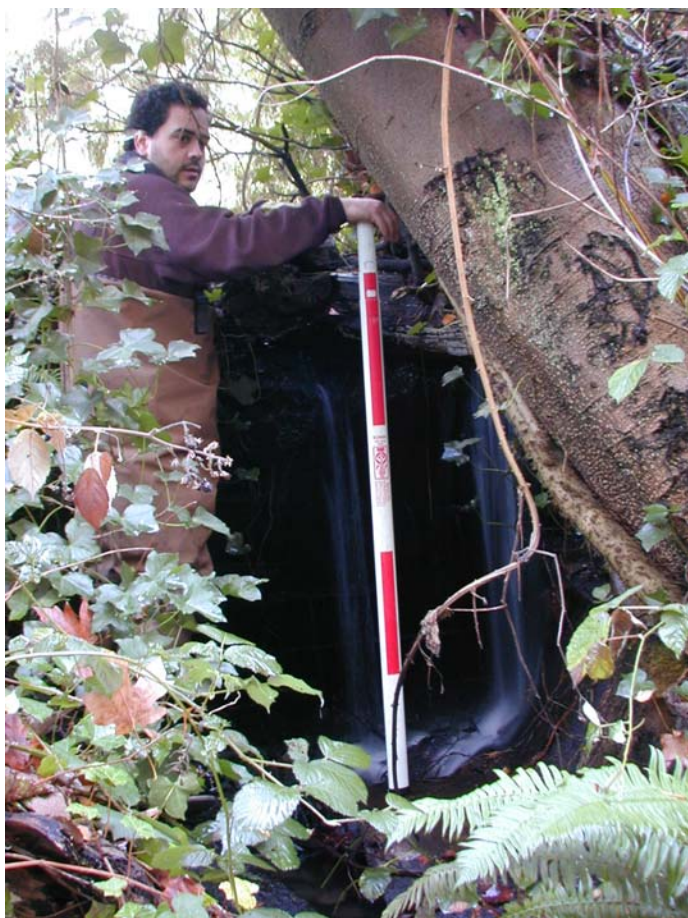
Photo 25. Concrete weir #3

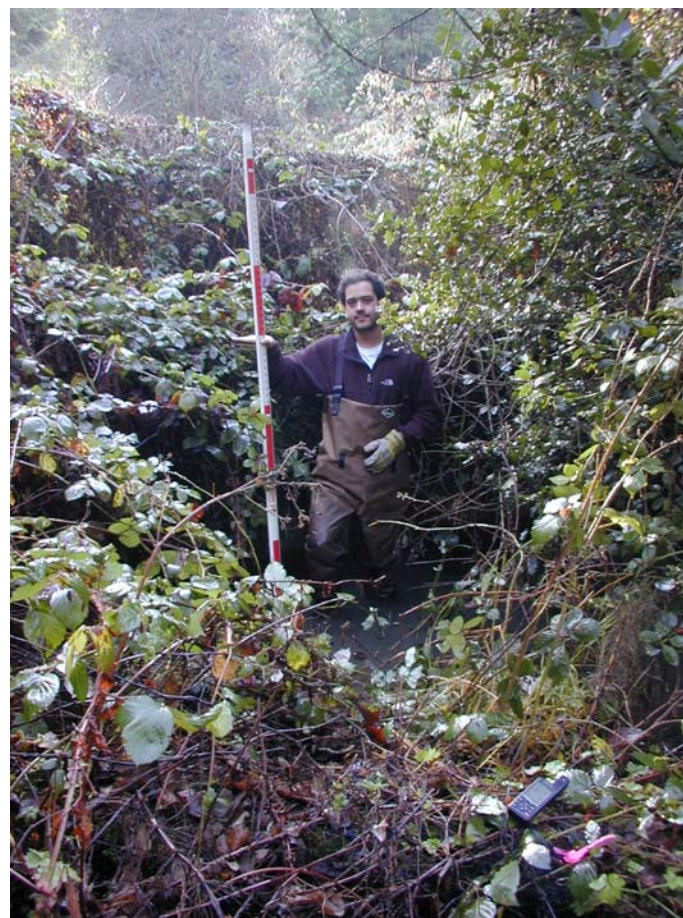
Photo 26. Concrete weir #4

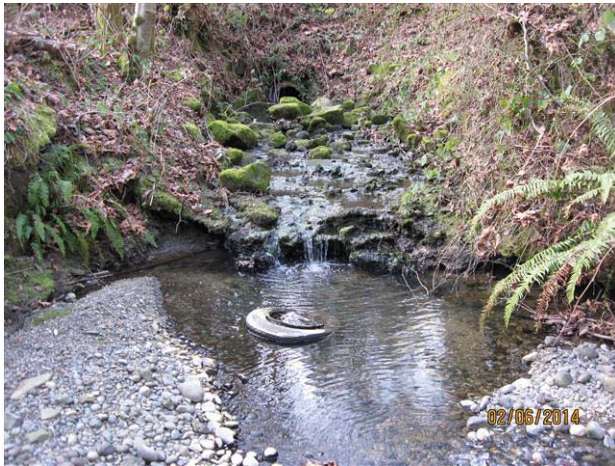
Figure 4. Trib 60M (WP 2)

With the exception of the lower 45 feet of Trib 60M (Figure 4), no tributaries containing usable fish habitat were found. A natural migration barrier exists on Trib 10M near the confluence, however, the barrier may be man-influenced. It was difficult to survey under the dense blackberry, and the lack of habitat upstream made positive identification irrelevant.

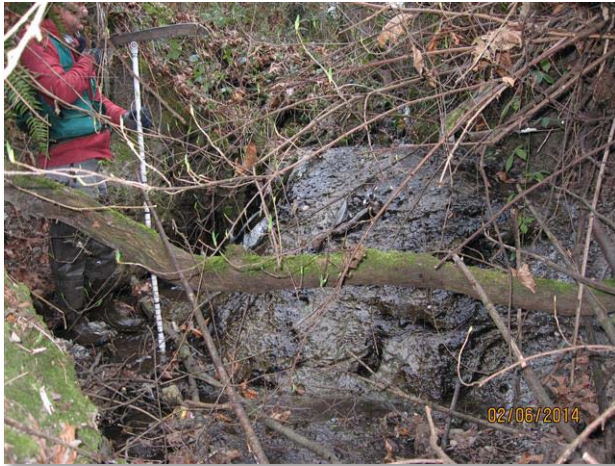
Figure 14. Puget Creek (820m – Barrier)

A single natural fish migration barrier was found on the mainstem of Puget Creek (Figure 14). It is located 2,690 feet upstream of Puget Way SW and about 75 feet downstream of SW Dawson Street. The barrier consists of two contiguous parts: a 3.5 to 4-foot high bedrock (till) outcropping with a 100% slope, followed immediately by a 4-foot high 33 percent grade cascade. There are no pools at the base or intervening steps from which fish could launch to move up the obstruction. This area of Puget Creek, and the reach upstream to the headwater reportedly goes dry during the typical summer for up to 4 months (Tabor et.al. 2010, Bonoff 2014).

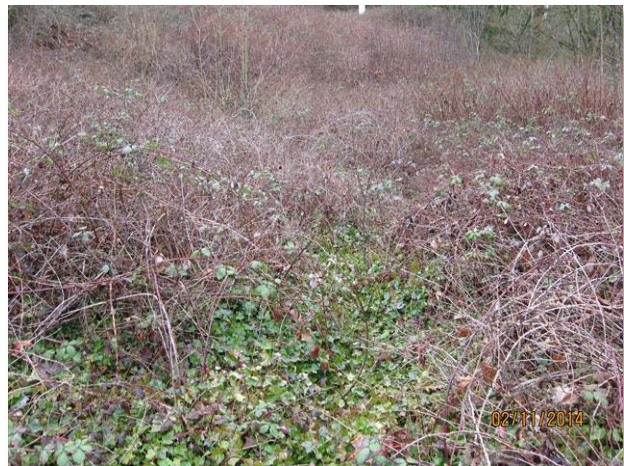
Figure 17. Trib 10M alluvial fan

Trib 10M is a natural watercourse that probably does not meet minimum physical characteristics to be presumed fish-bearing. Spots surveys found gradients approaching and exceeding 20 percent, channel widths less than 3-feet, almost no usable fish habitat, very little water during the winter (Figure 17), and what is believed to be natural fish-passage obstructions near the confluence with Puget Creek (Figure 18). Because fish cannot currently reach Trib 10M, detailed studies needed to verify water type were not completed.
